CHAPTER 3
LARGE-PANEL HOUSES

3.2 Analysis of damage to load-bearing structures of large-panel buildings caused by military operations

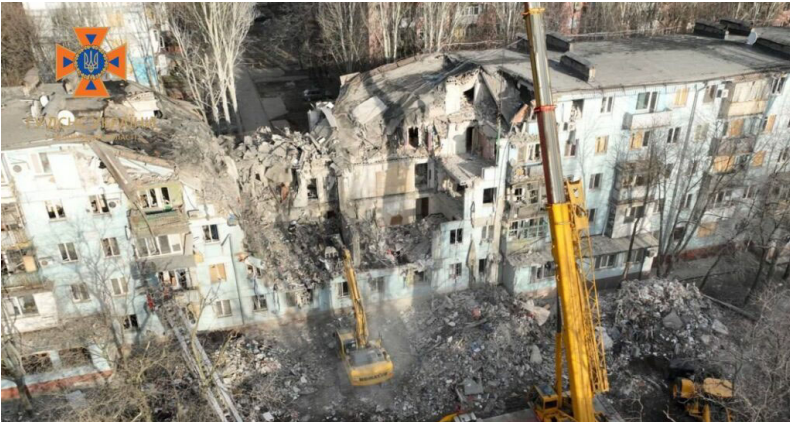
Figure 3.2 shows the consequences of hitting a multi-story residential building in Zaporizhzhia on March 2, 2023 [82]. A section of a large-panel building was directly hit by an S-300 missile, which destroyed 25 of the 80 apartments and made another 10 uninhabitable. After the missile hit, the upper floors were destroyed due to the blast wave. In general, it should be noted that the V-shaped nature of the destruction is quite typical for missile

hits, when after the explosion the first floors remain relatively less damaged, while the upper floors are destroyed. This can be explained by the nature of the action of missile weapons, which strike at an angle of 80-90° to the ground. Also interesting in this case is the fact that when the upper floors were destroyed, despite the action of the blast wave and the occurrence of non-projectile loads, the lower floors under the destroyed ones retained their stability and no cascading destruction occurred, when under the action of increasing loads from above, the lower floor collapses, even if it was not directly destroyed by the action of the shock wave, which indicates significant reserves of the bearing capacity of large-panel buildings to perceive loads applied directly from above.

**Figure 3.2 – Consequences of a building hit
in the city of Zaporizhzhia [82]**

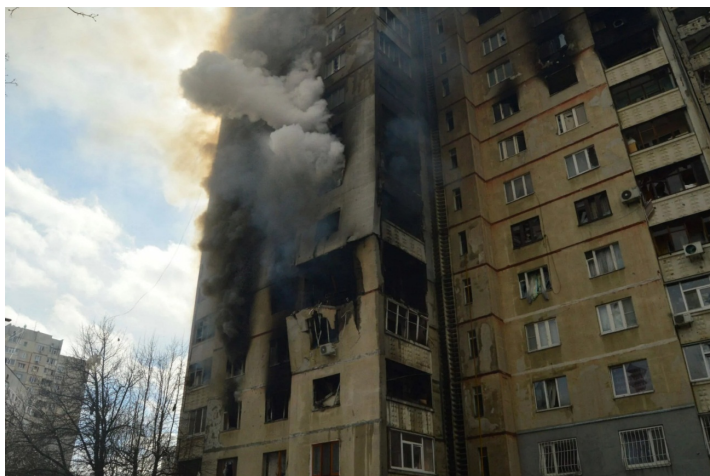
Analyzing the photos shown in Figures 3.3–3.5, it should be noted that single artillery hits do not pose a danger to the building in themselves, and

even when one or more external panels are destroyed as a result of direct hits, the adjacent panels generally retain their design position. However, compared to the effects of cruise missiles, a much greater danger to the building is posed by a fire, which can start especially after being hit by shells from multiple launch rocket systems (Grad, Uragan, Smerch, and the like). However, it should be noted that in this case, the metal elements of the assembly joints did not collapse, which prevented the destruction of the entire building.

Figure 3.3 – Multi-storey building on Pivchnaya Saltivka in April 2022 [50]

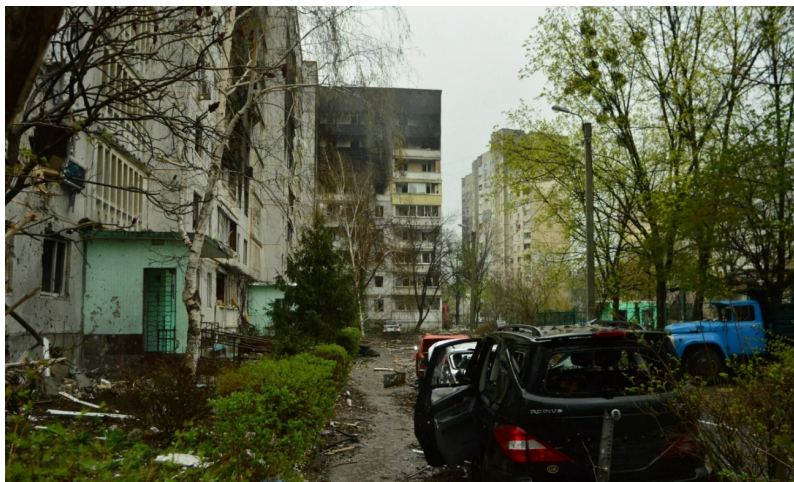
Figure 3.4 – Multi-storey building on Pivchnaya Saltivka in April 2022 [50]

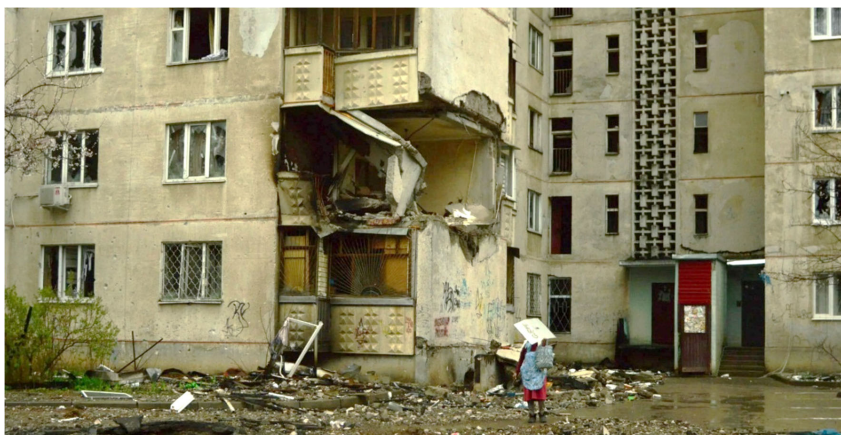
Figure 3.5 – Multi-storey building on Pivchnaya Saltivka in April 2022 [50]

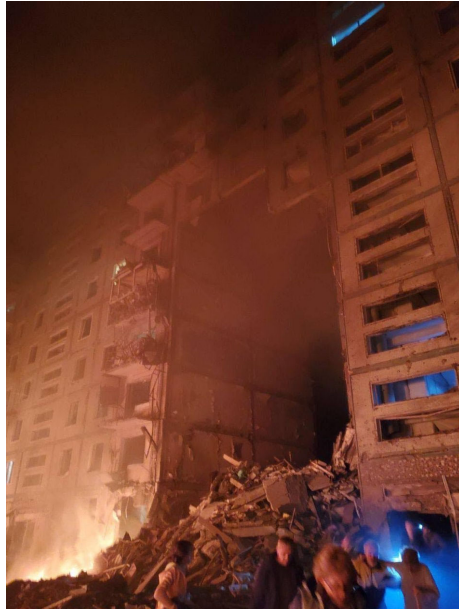
Figure 3.6 shows an image of the immediate consequences of the rocket attack on Zaporizhia on October 9, 2022 [39]. It should be noted the atypical nature of the destruction, which can probably be explained by the deviation of the enemy missile from the course due to operator error, electronic warfare systems or the results of the air defense systems action. As a result of the above factors, the impact did not occur from above, but perpendicular to the facade of the building on the lower floors, which led to destruction typical of a gas explosion in a building when there is a cascading destruction of apartments located one above the other.

Figure 3.6 – Missile strike on Zaporizhia on October 9, 2022 [39]

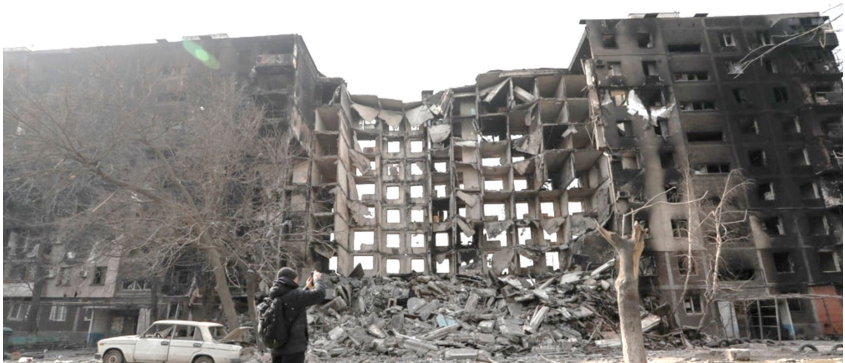
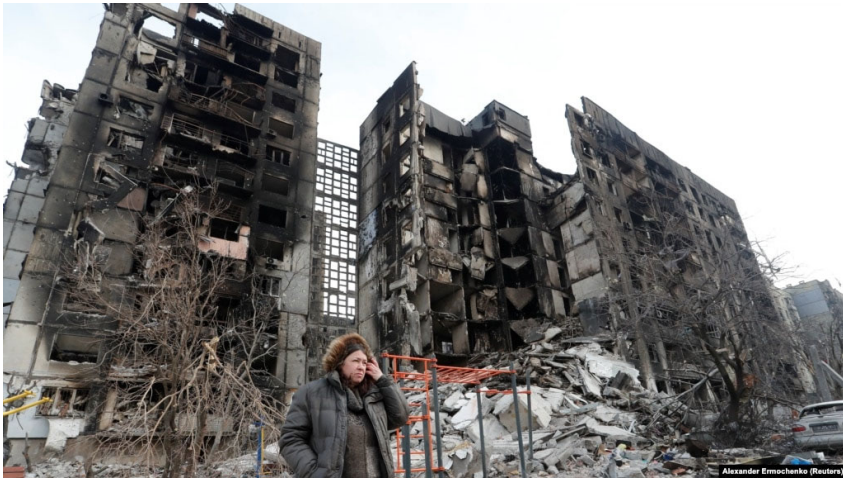
Figure 3.7 – Consequences of Russian strikes on Mariupol, March 2022 [21]

Figure 3.8 – Consequences of Russian strikes on Mariupol, March 2022 [21]

Figures 3.7 and 3.8 show some of the hundreds of destroyed prefabricated buildings in Mariupol. The fighting in the city itself lasted for more than 3 months, during which a significant part of it was destroyed. The photos show the consequences of aerial bombardment and direct fire from tanks.

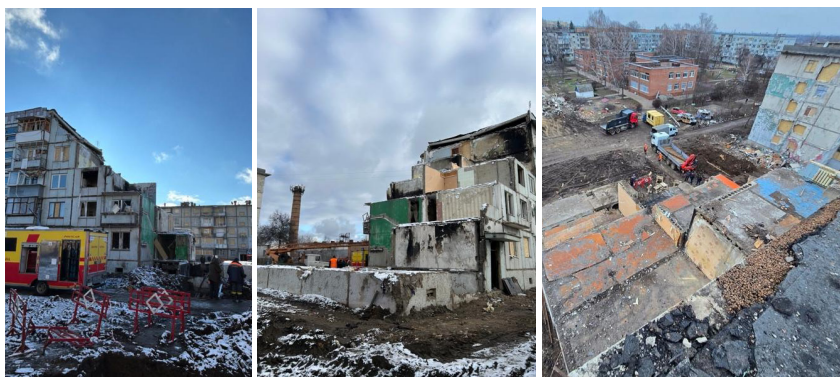
Figures 5.9 show the consequences of the strike on the city of Poltava, which occurred on February 1, 2024. In general, the nature of the destruction is similar to the consequences of the strike shown in Figure 3.2 on the city of Zaporizhzhia, with the preservation of the “step” with the difference that in this case the impact occurred not in the center of the building but in its upper corner. A fire broke out on the spot. According to the acting chief of the Poltava OVA, the aircraft used a supersonic Kh-22 [89] missile with an

estimated warhead weight of 600-700 kg of TNT equivalent. This Soviet missile, designed for attacks on aircraft carriers, has relatively low accuracy and high (compared to Kalibr/Kinzhal) power.

Figure 3.9 – House No. 7 hit by a rocket in Poltava [89]

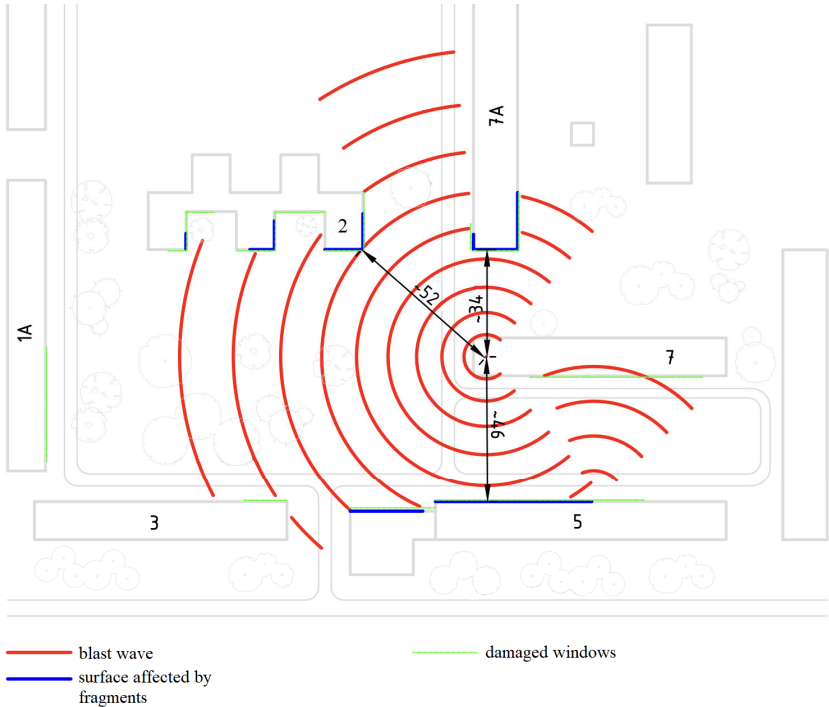
The situational diagram (see Figure 3.10) shows the approximate location of the missile impact, the propagation of the blast wave, and the surfaces of buildings affected by primary and secondary fragments (according to UFC 4-010-01 [97]). Primary fragment is a fragment of a shell or container of an explosive substance or a fragment of an object that has come into contact with the explosive substance, and secondary fragment is a fragment that is formed as a result of the explosion when the blast wave interacts with objects or structures located near the source of the explosion, i.e., parts of structures, machines, small tools, etc.

After inspecting the surrounding buildings, it was discovered how the blast wave spread. Thus, after the impact, almost the entire entrance was destroyed, except for one apartment on the first floor. It is visible that the neighboring house No. 5 also received damage due to the impact of fragments from the explosion and the blast wave. It should be noted that it reflected the wave and it spread back. This is indicated by the partially damaged windows of house No. 7 on the opposite side from the impact. On the other hand, the blast wave passed along the tangent of house 7A, reaching preschool institution No. 2 and the houses opposite. Due to the

non-linear configuration of the kindergarten building, the impact of the blast wave also spread to the surfaces inside between the ledges, causing damage to the windows. Small fragments of panels were found not far from the house No. 1A, which also indicates that the blast wave reached it, but its energy was not enough to cause damage.

Figure 3.10 – Situational diagram of the location of houses [88]

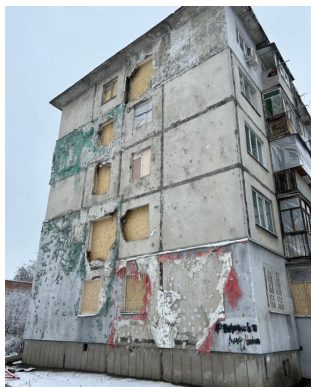
The house No.7A (see Figure 3.11) [89] suffered the most from the debris, as it was the closest and the impact probably came from its side. Upon examination, the greatest damage from the debris was in the weakest parts of the panel – the window openings. Along the house, where the debris flew tangentially, there is minor damage to the protruding balcony structures. On the opposite side, parallel to the house hit by the

**Figure 3.11 – Damaged
façade of a house No.7A
[89]**

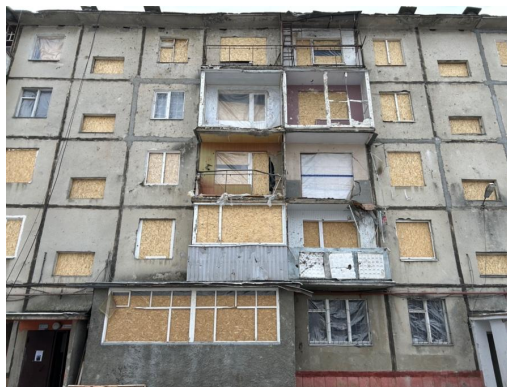
rocket, is house No. 5, which was also damaged by debris, as can be seen in the photo (see Figure 3.12): the facade of the house is chipped, and in some places the debris is stuck in the concrete panel. Preschool institution No. 2 was also hit, where the inspection revealed depressions in the brickwork. In the kindergarten itself, debris was also found, which broke through the windows and passed through the room closest to the explosion site (see Figure 3.13) [88].

**Figure 3.12 – Damaged
by debris and blast wave,
the facade of a house No.5 [89]**

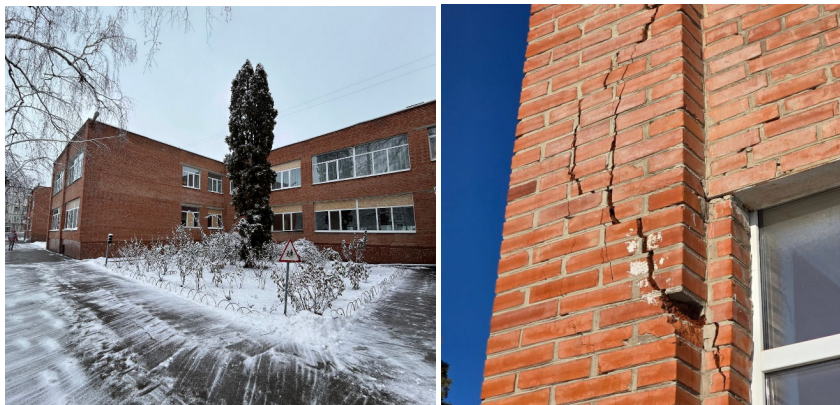
Figure 3.13 – Damage to preschool educational institution No. 81[88]

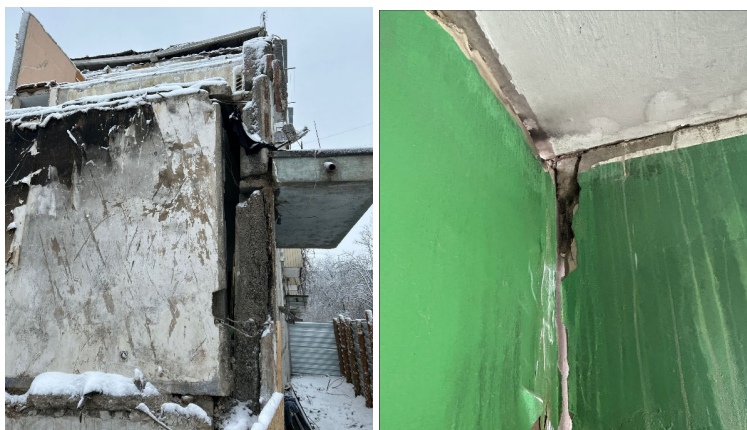
The partially surviving panels of the apartments on the first and second floors of the right wing of the entrance will also have to be dismantled, since further operation of such premises is dangerous, since the joints of the concrete panels were damaged, and the panels themselves changed their position relative to each other (opening of seams, deviation of the panel from the vertical position, formation of cracks as shown in Figure 3.14).

Figure 3.14 – Opening of seams and damage to the joints of the panels of the entrance group of the first entrance
